Dolores River Boating Advocates

# DOLORES RIVER REPORT CARD

## 2023

*An annual assessment of the health of southwest  
Colorado's Dolores River in 2023*

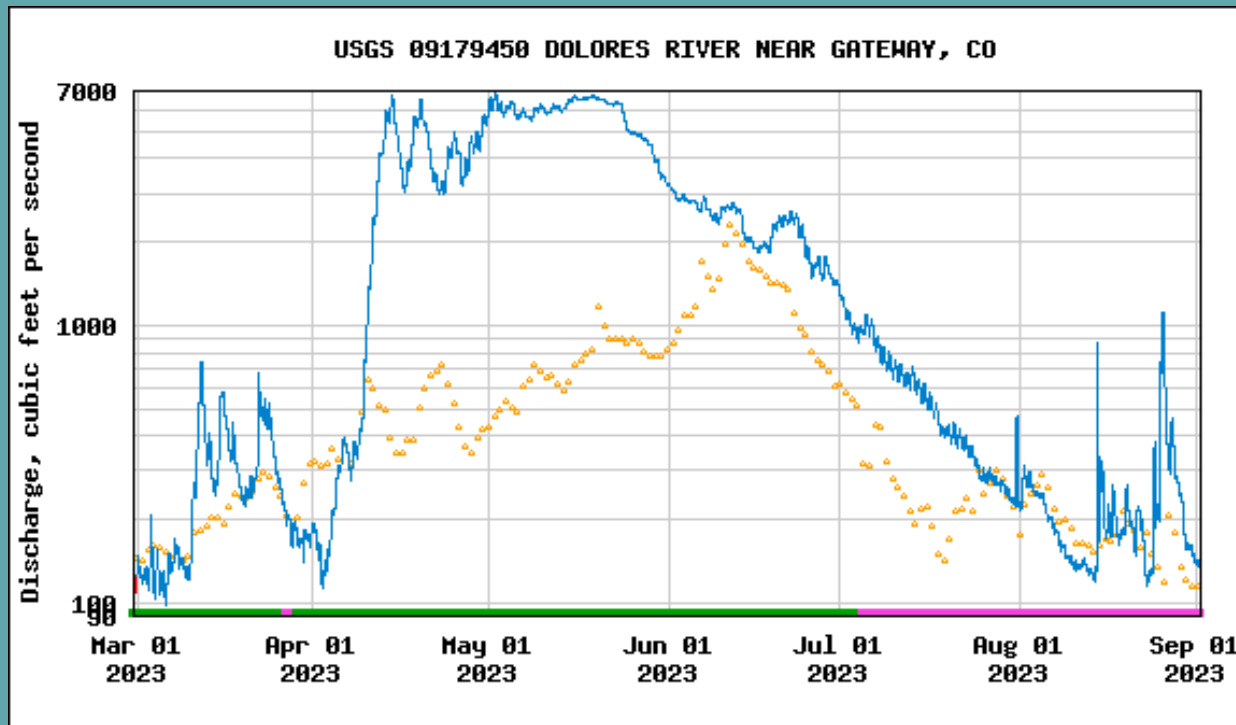
Figure 1: Dolores River at Gateway between March 1-September 1, 2023

2023 had the most dynamic flow regime in many years, with flows from low elevation snowpack peaking prior to the release from McPhee. Once release began, flows were above 4,000 cfs, and below the confluence with the San Miguel, above 6,000 cfs.

While flows in the spring are almost always the most dynamic, once the spill concluded, a fixed amount was released for the remainder of the year, which does **not** mirror the flow regime above the dam.
